ErSed Reference: 21003-ERMR-12-220407

**Re: SSD-9522: Kemps Creek Warehouse, Logistics and Industrial Facilities Hub (the Yards)**

**Environmental Representative: Monthly Report (ERMR #12)**

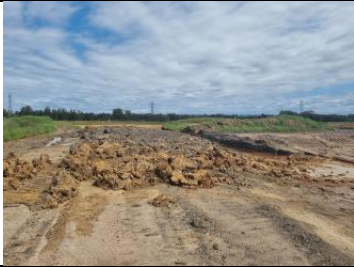
<table><tr> <th colspan="2">Photos and comments from inspections</th> </tr><tr> <td> </td> <td>11/03/22  The main site entrance in is shut The wheel wash and exit is clear of sediment  The wheel wash basin is full and will need to be dewatered to the main basin once other site water has been managed.</td> </tr></table>

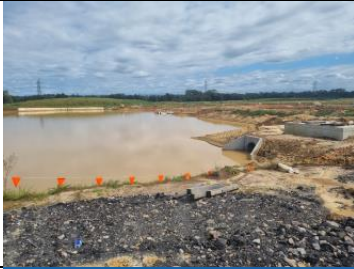
11/03/22  
The inlet to the basin has failed and will need to be reconstructed.

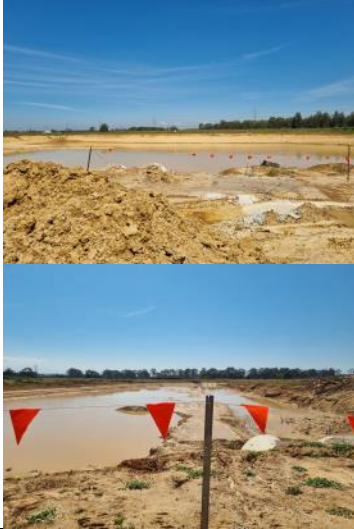
11/03/22  
The spillway top the main basin was not engage and the overflow is instead from the northern extent of the secondary basin.

This overflow is stable over thick vegetation  
This area should not be accessed with machinery unless it is to modify and formalise the access or raise it to ensure the design spillway is engaged.
