**RE: Frasers Property - 141-251 Aldington Road, Kemps Creek NSW 2178 SSD-17552047 – ER Monthly Report for March 2026**

**1. Frasers Property - 141-251 Aldington Road, Kemps Creek NSW**

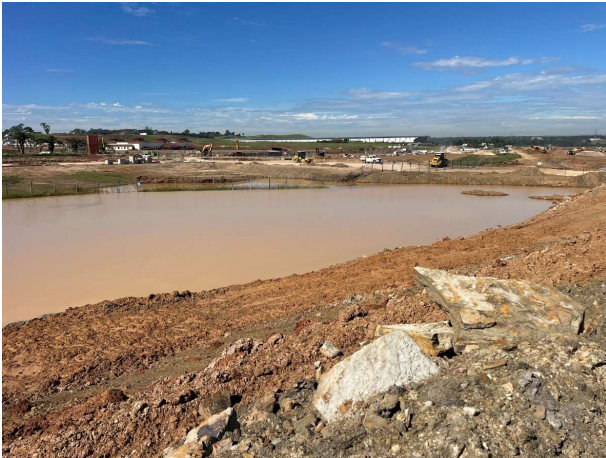
<p><b>Eastern boundary:</b> Water pooled in an onsite depression where it is behaving like a sediment basin</p>	<p><b>Northern boundary:</b> The crushing equipment has utilised water sprays to minimise dust</p>

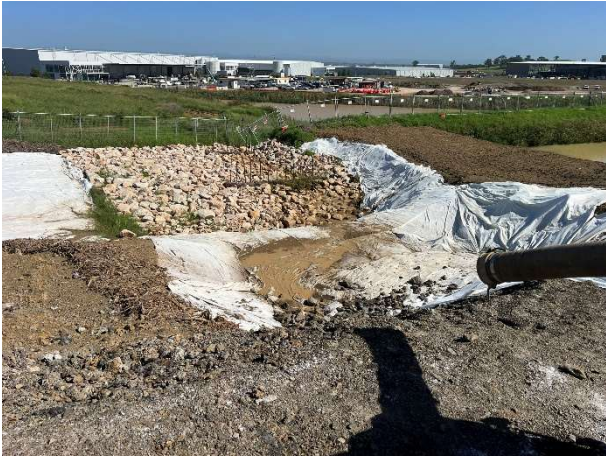
<p><b>Basin F:</b> The spill way on basin F is effective, ER reminded project to monitor levels of built-up silt</p>	<p><b>Basin H:</b> The mulch controls downstream of basin H have been effective in retaining sediment on site</p>

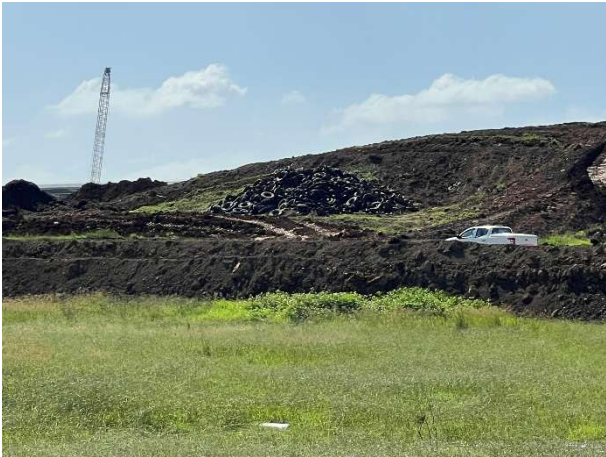
<p><b>Catchment 5:</b> Old tyres are stored on site and will be cleaned prior to being sent off site for disposal</p>	<p><b>Catchment 5:</b> Minor levels of dust were observed from the scrapers. It is noted that the dust did not leave the project boundary.</p>

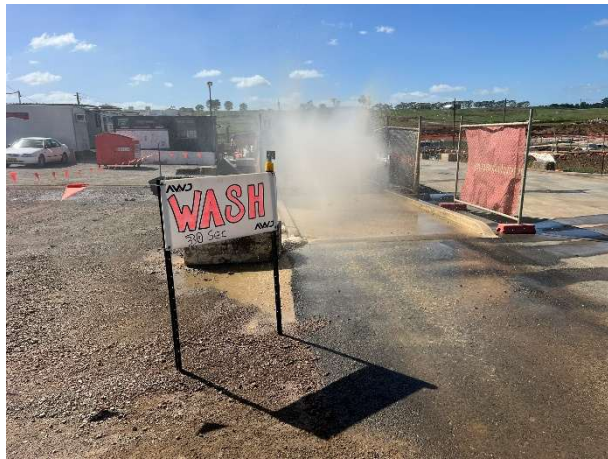
**Entry / exit:** The wheel wash was in use for all heavy vehicles.

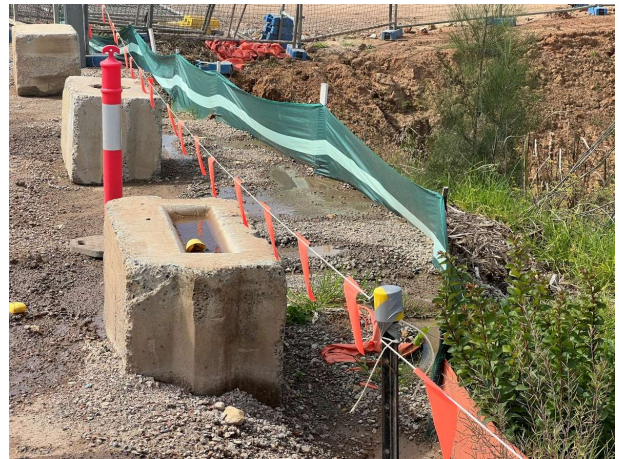
**Basin A:** ERSED controls were effective, ER reminded contractor that when the capacity is reduced by 70% it is to be cleaned out
